DEPARTMENT OF TRANSPORTATION

Contract #: 04-0120F4Cty: SF/ALA Rte: 80 PM: 13.2/13.9File #: 69.28**WELDING INSPECTION REPORT****Resident Engineer:** Pursell, Gary**Address:** 333 Burma Road**City:** Oakland, CA 94607**Report No:** WIR-002537**Date Inspected:** 15-May-2008**Project Name:** SAS Superstructure**OSM Arrival Time:** 1730**Prime Contractor:** American Bridge/Fluor Enterprises, a JV**OSM Departure Time:** 800**Contractor:** Zhenhua Port Machinery Company, Ltd (ZPMC), Changxing Island **Location:** Shanghai, China**CWI Name:** C. M. Chen**CWI Present:** Yes No**Inspected CWI report:** Yes No N/A**Rod Oven in Use:** Yes No N/A**Electrode to specification:** Yes No N/A**Weld Procedures Followed:** Yes No N/A**Qualified Welders:** Yes No N/A**Verified Joint Fit-up:** Yes No N/A**Approved Drawings:** Yes No N/A**Approved WPS:** Yes No N/A**Delayed / Cancelled:** Yes No N/A**Bridge No:** 34-0006**Component:** Tower & OBG**Summary of Items Observed:**

WELDING INSPECTION REPORT

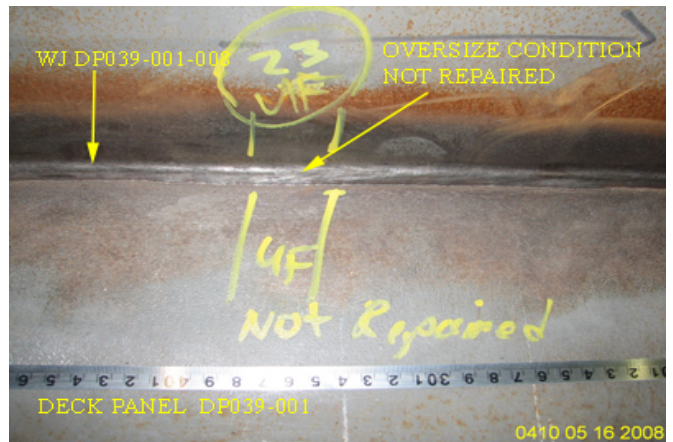
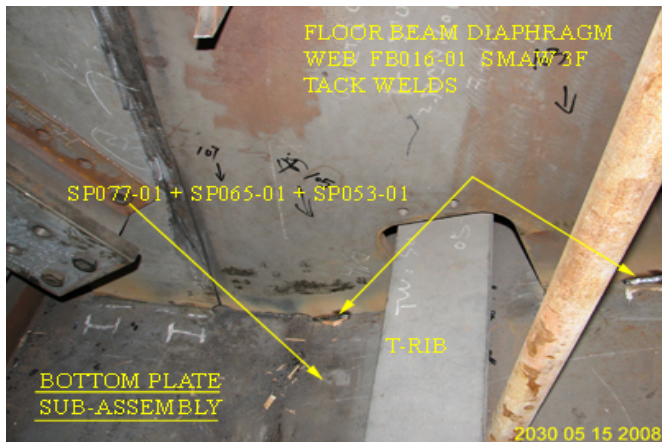
The QA Inspector randomly observed ZPMC welder Xu Liguang ID Number 200114, utilizing the Shielded Metal Arc Welding (SMAW) Process to tack weld during fit up, the bottom of a web of Floor Beam FB016-01 to Side Plate Sub-Assembly SP053-01 + SP065-01 + SP077-01. The QA Inspector randomly observed ZPMC CWI C. M. Chen monitoring weld parameters. The attached photographs provide additional detail.

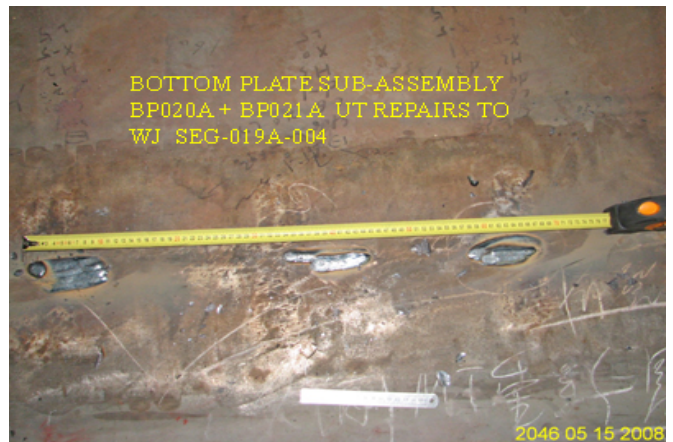
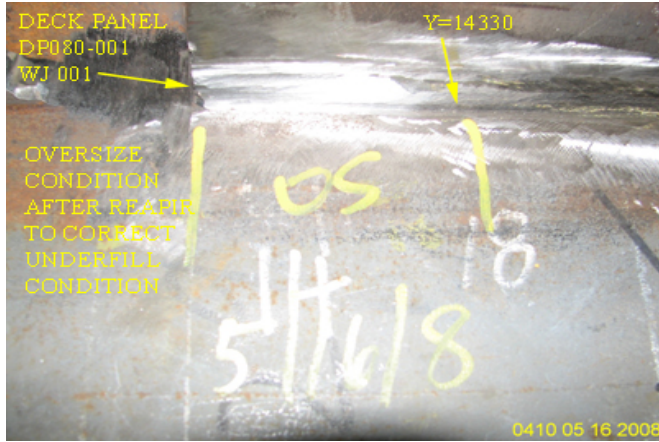
The QA Inspector randomly observed a ZPMC helper grinding flush weld reinforcement, to repairs to WJ

SEG-019A-004 in Bottom Plate Sub-Assembly BP020A + BP021A. The attached photographs provide additional detail.
